Manhole Inspection Summary

Manhole # S53I__038MH

Inspection ☐ Is Incomplete Rating: **3) Fair**

Location Address: **rear 514 s east av**

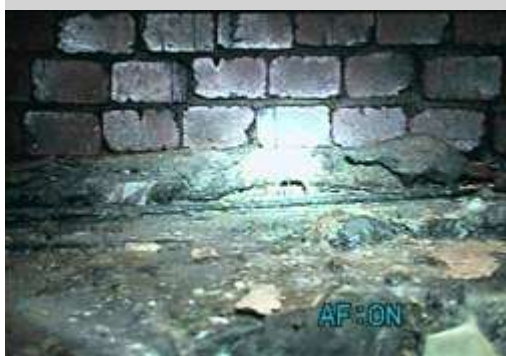
Miscellaneous

bench debris

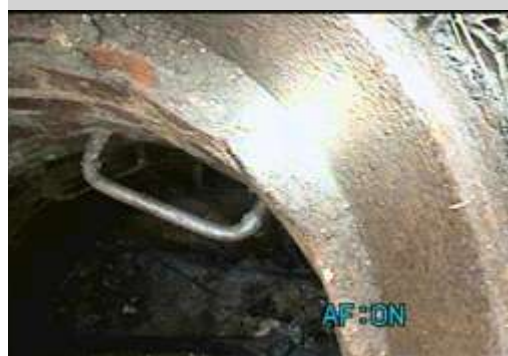
Defect 2

Frame Offset: **2** (in.) Condition: ☒ Sound ☐ Cracked ☐ Leaks

offset

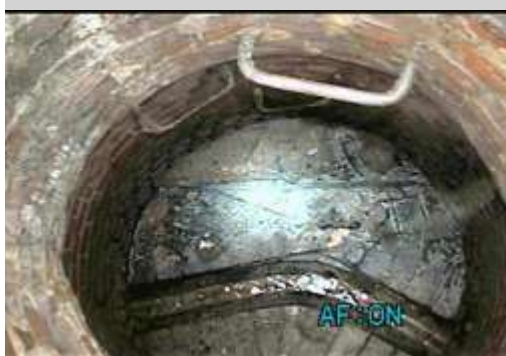
Defect 1

Steps Count: **3** Missing: **0** ☒ **Corroded**

corr steps

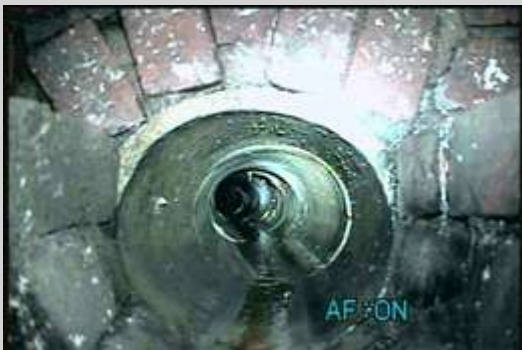
12 O'Clock Outflow

8 in. Circular Gravity Sewer
Pipe Out @ 12 O'Clock

Pipe Material: **Clay** ☐ Pipe Lined

Invert Depth: 7.29 (ft.) Flow Characteristics: **Fast**

Infiltration: **None** Pipe Seal Cond: **Unknown**

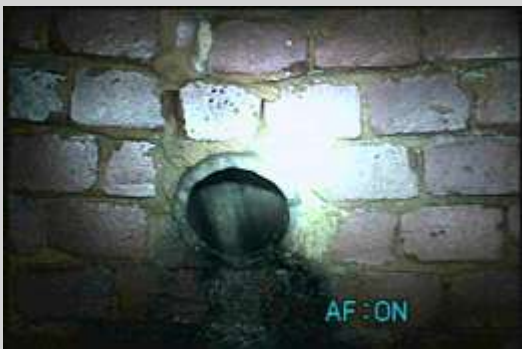
6 O'Clock Inflow

4 in. Circular Gravity Sewer
Pipe In @ 6 O'Clock

Pipe Material: **Clay** ☐ Pipe Lined

Invert Depth: 4.25 (ft.) Flow Characteristics: **None**

Connects To: **House connection / Service line**

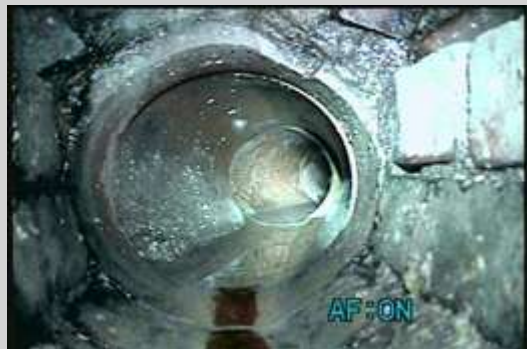
7 O'Clock Inflow

8 in. Circular Gravity Sewer
Pipe In @ 7 O'Clock

Pipe Material: **Clay** ☐ Pipe Lined

Invert Depth: **6.96** (ft.) Flow Characteristics: **Slow**

Infiltration: **None**
